Techforce Electrical
1/14 Blackly Row
Cockburn Central WA 6164
P – 0425 830 447
E – info@techforceelectrical.com.au

Thermal Image Report

Sample Client

July 2013

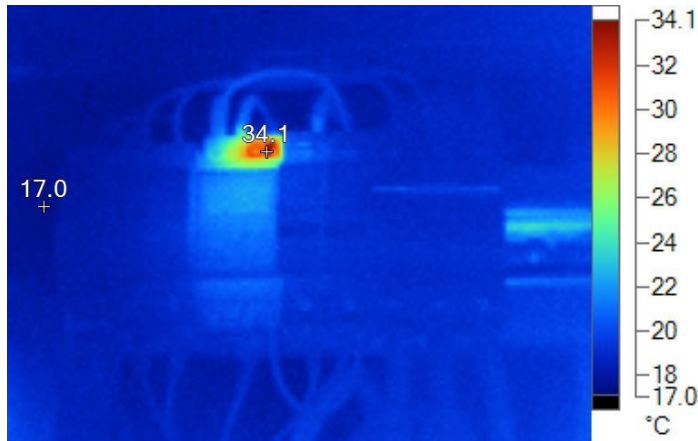
IR001271.IS2

Inspection Date:	6/25/2013 10:17:45 AM	Location	Student Housing
Equipment	Switchboard	Equipment Name:	Main Switchboard
Potential Problem:	Nil	Repair Priority:	4
Emissivity:	0.76	Reflected Temperature:	13.3 °C
Camera Manufacturer	Fluke Thermography	Camera:	09060417
Hot Image Marker:	34.1°C	Cold Image Marker	17.0°C

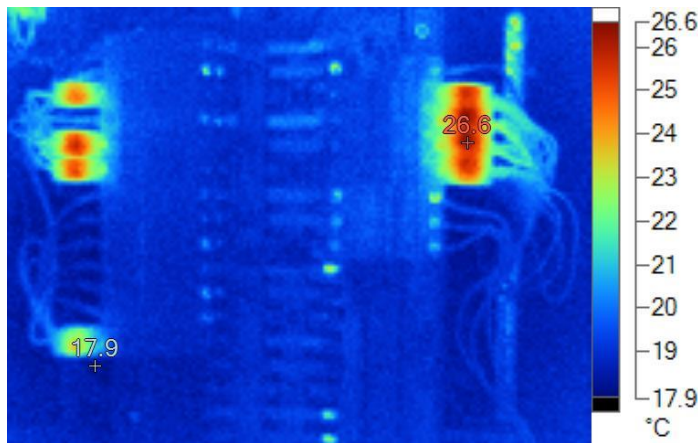
IR001273.IS2

Inspection Date:	6/25/2013 10:20:12 AM	Location	Student Housing
Equipment	Switchboard	Equipment Name:	Main Switchboard
Potential Problem:	Nil	Repair Priority:	4
Emissivity:	0.27	Reflected Temperature:	26.0 °C
Camera Manufacturer	Fluke Thermography	Camera:	09060417
Hot Image Marker:	26.6°C	Cold Image Marker	17.9°C

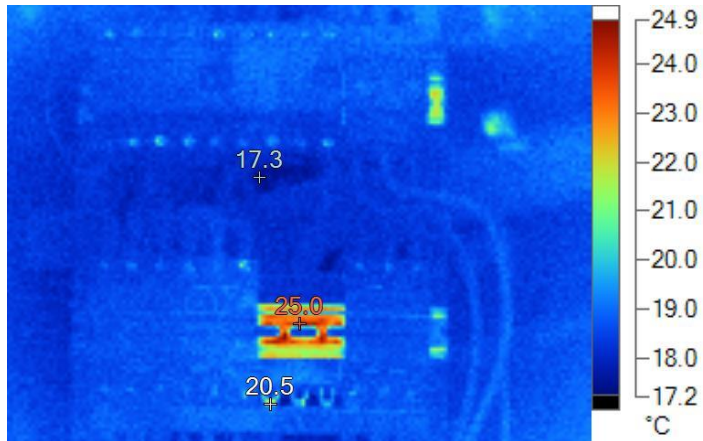
IR001274.IS2

Inspection Date:	6/25/2013 10:23:23 AM	Location	Student Housing
Equipment	Switchboard	Equipment Name:	Main Switchboard
Potential Problem:	Nil	Repair Priority:	4
Emissivity:	0.27	Reflected Temperature:	26.0 °C
Camera Manufacturer	Fluke Thermography	Camera:	09060417
Hot Image Marker:	20.5°C	Cold Image Marker	17.3°C

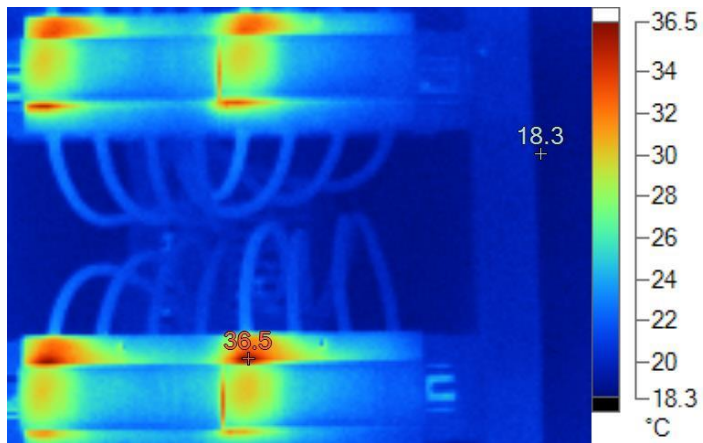
IR001275.IS2

Inspection Date:	6/25/2013 10:31:24 AM	Location	Student Housing
Equipment	Switchboard	Equipment Name:	Main Switchboard
Potential Problem:	Nil	Repair Priority:	4
Emissivity:	0.27	Reflected Temperature:	26.0 °C
Camera Manufacturer	Fluke Thermography	Camera:	09060417
Hot Image Marker:	36.5°C	Cold Image Marker	18.3°C

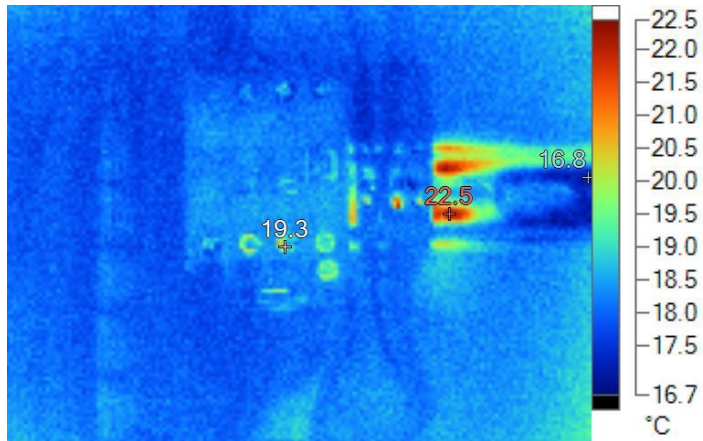
IR001277.IS2

Inspection Date:	6/25/2013 10:39:53 AM	Location	Student Housing
Equipment	Switchboard	Equipment Name:	Distribution Board 1
Potential Problem:	Nil	Repair Priority:	4
Emissivity:	0.27	Reflected Temperature:	26.0 °C
Camera Manufacturer	Fluke Thermography	Camera:	09060417
Hot Image Marker:	19.3°C	Cold Image Marker	16.8°C

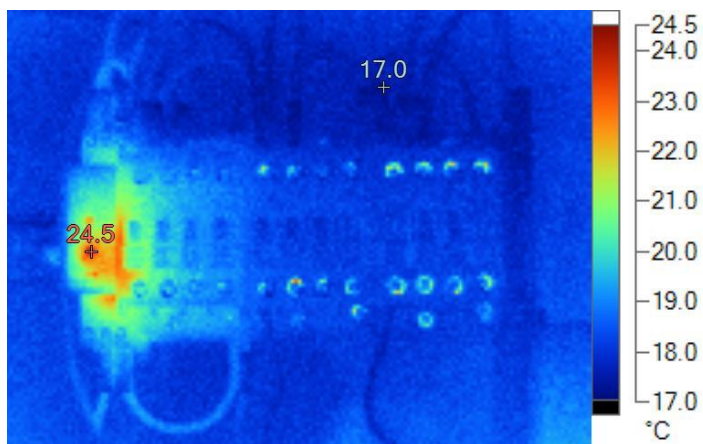
IR001278.IS2

Inspection Date:	6/25/2013 10:40:13 AM	Location	Student Housing
Equipment	Switchboard	Equipment Name:	Distribution Board 1
Potential Problem:	Nil	Repair Priority:	4
Emissivity:	0.27	Reflected Temperature:	26.0 °C
Camera Manufacturer	Fluke Thermography	Camera:	09060417
Hot Image Marker:	24.5°C	Cold Image Marker	17.0°C
